Lower DuPage Watershed Watershed Assessment & Reconnaissance

Geosyntec
consultants

Project Number: CWR8255

January 31, 2011

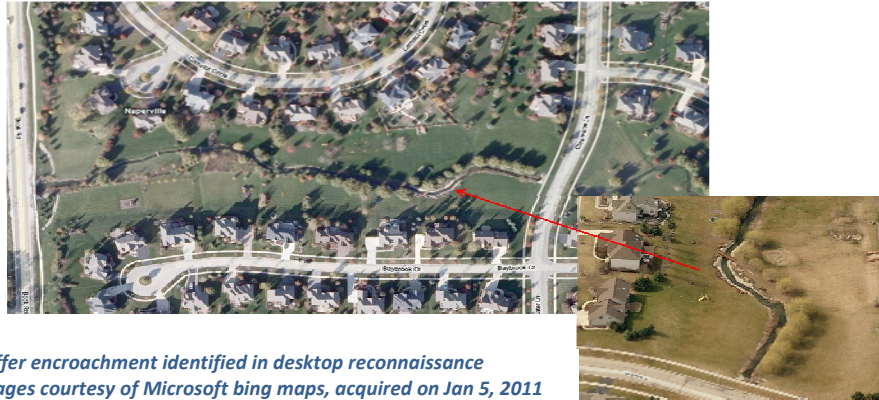
*Buffer encroachment identified in desktop reconnaissance
Images courtesy of Microsoft Bing maps, acquired on Jan 5, 2011*

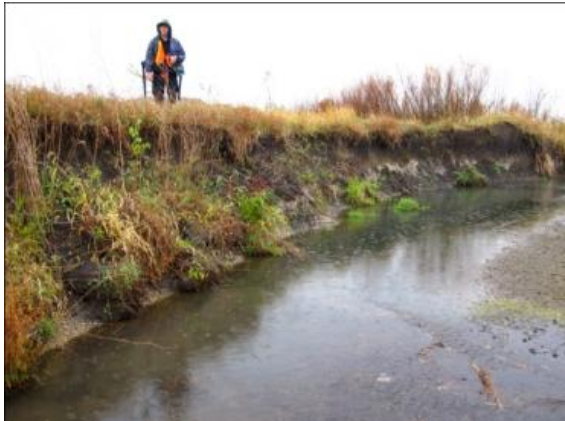
Bank erosion

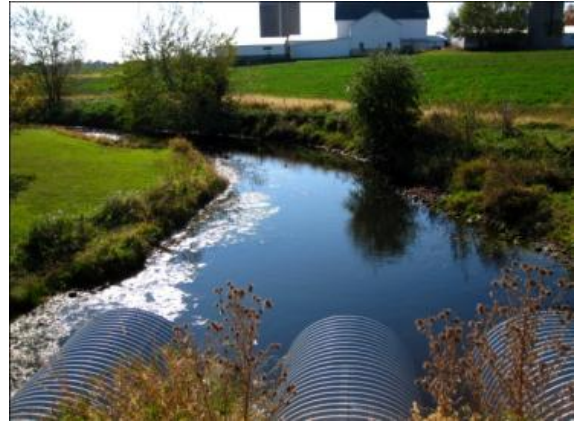
Agricultural channel

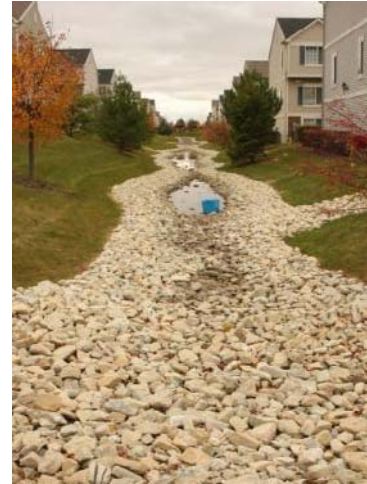
Rock-lined swale in residential complex

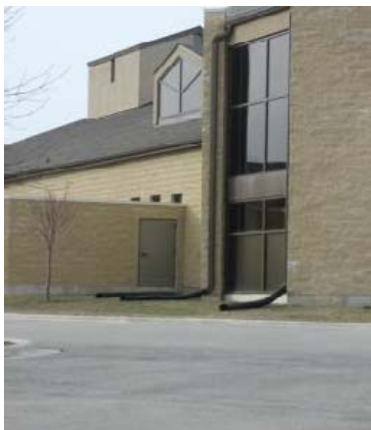
Roof runoff retrofit opportunity

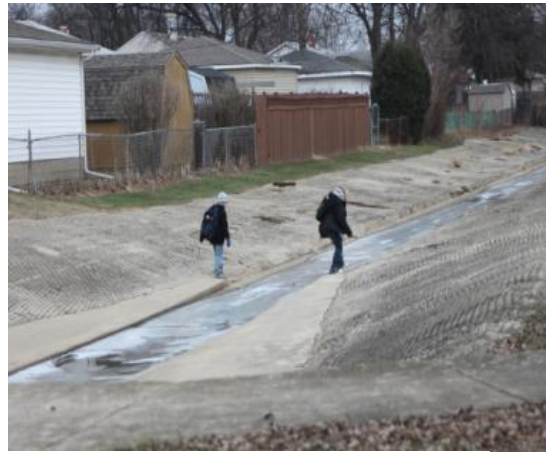
Swale through urban neighborhood
